Test Report

Sample Name. PU Hydraulic tubing
Sample Reference /
Material Inner tube PA nylon material, Middle layer of high strength fiber weave,
Outer tube PU material
Sample Description /
Application Field. Marine vessels
Buyer /
Supplier /
Quantity 10pcs

Test Specification. SAE J343

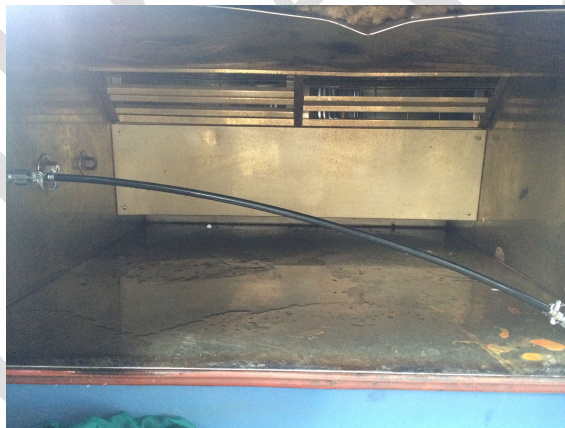
(6) Sample Photo During The Test:

- 1) Fix the sample on the device, increased at a constant rate so as to attain the specified minimum burst pressure within a period of not less than 15 s nor more than 60 s.
- 2) Test requirements: Burst pressure ≥ 27.6 MPa

Sample No.	Burst pressure (MPa)
1#	35.22

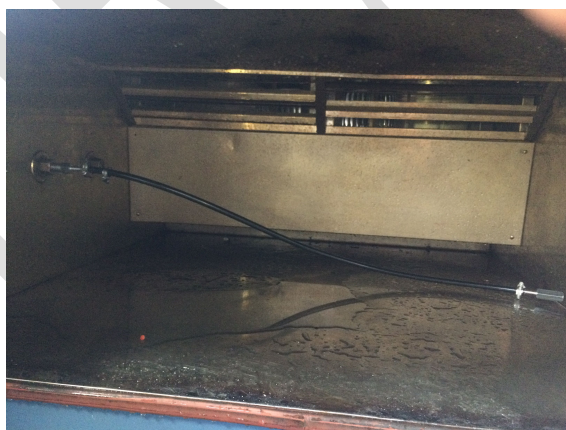
(6) Sample Photo During The Test:

- 1) Fix the sample on the device, to a hydrostatic pressure of 70% of the specified minimum burst pressure (19.32MPa) for a period of between 5.0 to 5.5 min. Reduce the fluid pressure to 0 MPa. Re-apply the 70% of minimum burst hydrostatic pressure for another 5.0 to 5.5 min period. Reject assemblies showing leakage or failure
- 2) Test requirements: Test sample should no leakage or failure

Sample No.	Test result
2#	No leakage or failure

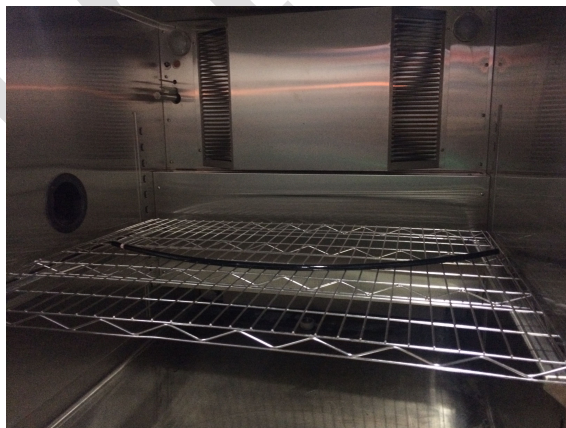
(6) Sample Photo During The Test:

- 1) Subject hose assemblies to the specified temperature (-18℃) in a straight position for 24 h. Then, while still at the specified temperature, the samples shall be evenly and uniformly bent once over a mandrel having a diameter equal to twice the specified minimum bend radius. Bending shall be accomplished within a period of not less than 8 s nor more than 12 s. After bending, allow the sample to warm to room temperature, visually examine it for cover cracks and subject it to the proof test. There shall be no cover cracks or leakage
- 2) Test requirements: there shall be no cover cracks or leakage

Sample No.	Test result
3#	No crack or leakage

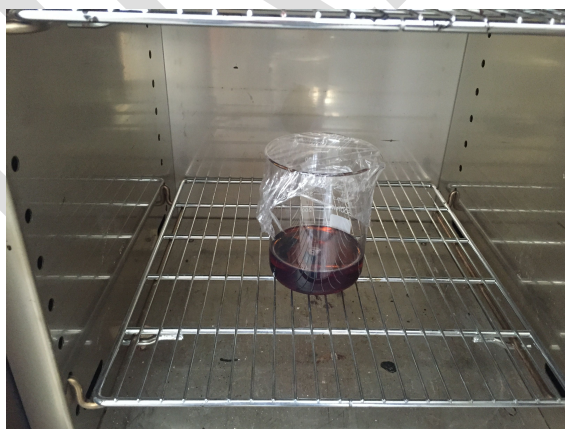
(6) Sample Photo During The Test:

1) Test fluid: IRM 903

2) Test time: 70h

3) Temperature: 100℃

Sample No.	Change in volume (%)	Average (%)
1	7.19	7.36
2	8.34	
3	6.55

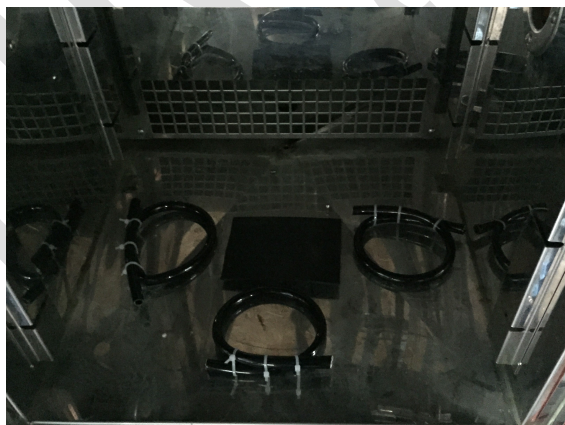
(6) Sample Photo During The Test:

- 1) After exposure to an air/ozone mixture for 70h with ozone at a partial pressure 50mpa there shall be no evidence of cracking or deterioration
- 2) Test requirements:no evidence of cracking or deterioration

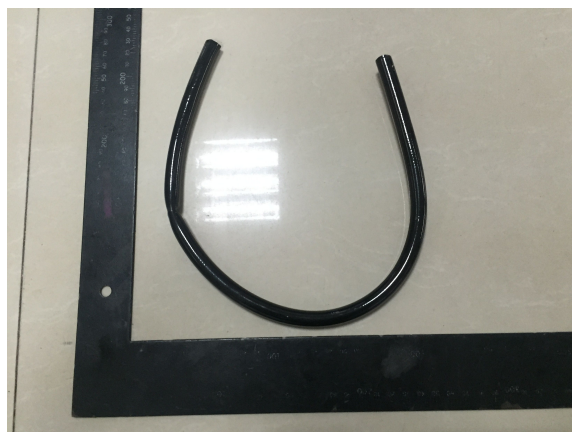
Sample No.	Test result
1#	No evidence of cracking or deterioration
2#	No evidence of cracking or deterioration
3#	No evidence of cracking or deterioration

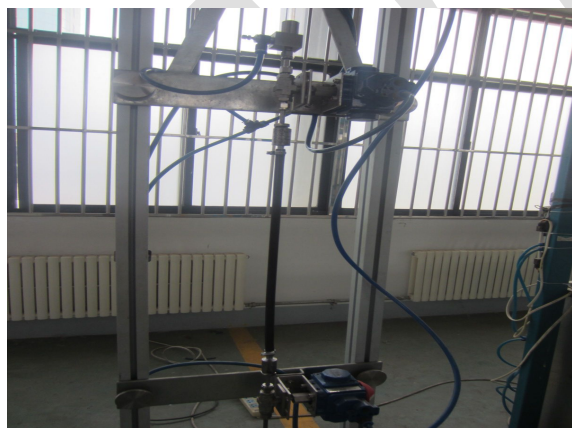
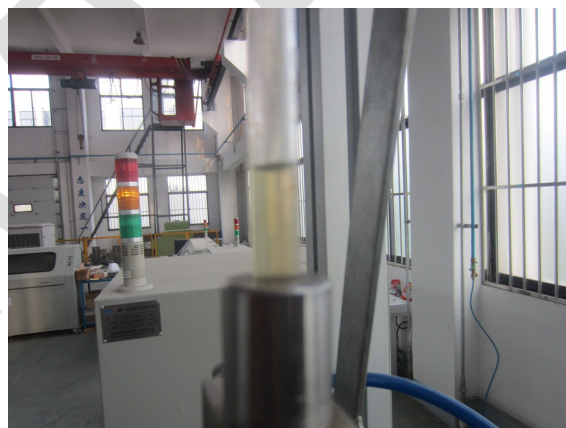
(6) Sample Photo During The Test:

- 1) Pressure rise rate: 180MPa/min,
- 2) Free length: 280mm

Sample Name.	Average expansion quantity (cc)	Volumetric expansion (cc/ft)
PU Hydraulic tubing	0.033	0.036
