Top 8 Reasons Hydraulic Hoses Fail

There are thousands of reasons a hydraulic hose can fail, but often, the most common failures could have been avoided with proper precautions. Below are eight of the most common reasons for hose failure and how to protect against them.

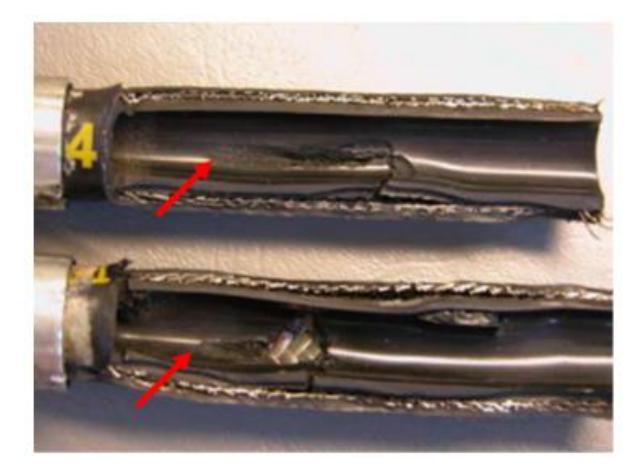
1. Tube erosion

Hydraulic hose tube erosion often causes external leakage. Tube erosion is usually caused by a concentrated high-velocity stream of fluid or by small particles in the fluid. The red arrows in the image point to the start of the erosion.

In order to avoid tube erosion, use Hose flow capacity nomogram to determine the proper hose size based on the recommended maximum velocities. Also, be sure that the hose assembly is not bent too tight for flow and that the fluid medium is not too abrasive for the inner tube of the hose. It is important to follow the maximum bend radius noted in the engineering specifications for each hose, as well as diameter, during the assembly process.

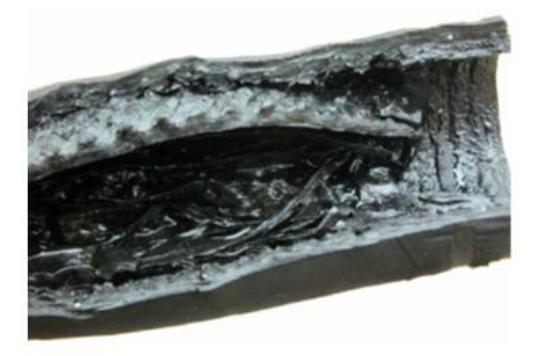
2.Fluid compatibility

System contamination and external leakage can be a direct result of fluid compatibility issues. Incompatible fluids will cause the inner tube of the hose assembly to deteriorate, swell, and delaminate. The inner tube can also partially wash out in some cases. The hose you order must be compatible with the fluid being conveyed.

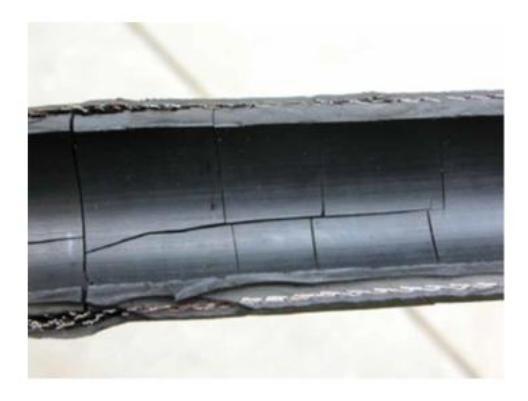
3. Dry air / aged air

The inner tube of hoses can develop numerous tiny cracks due to aged or dry air. This type of failure is sometimes hard to spot because the hose will remain flexible, however there will be signs of external leakage. Typically, there are no signs of cracking on the hose under the fittings.

To avoid dry or aged air problems, confirm your hose is rated for extremely dry air. Hoses with inner tubes of PKR or EPDM rubber are preferred for these applications. If possible, raise the dew point of the air.

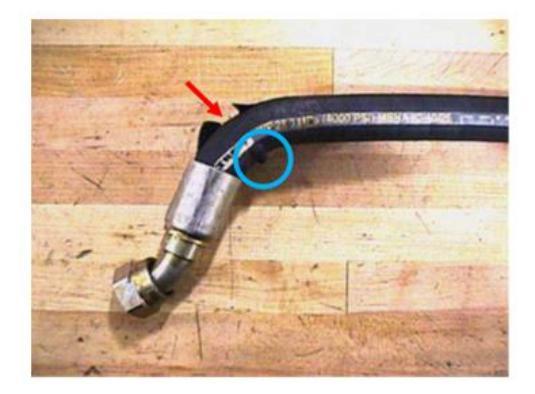
4. Minimum bend radius

Hose assemblies can fail relatively quickly if the minimum bend radius is not met. In this image, it is obvious that the tube and cover physically ripped apart at the outside of the bend, noted by the red arrow. The blue circle indicates where the tube and cover are buckled at the inside of the bend.

In vacuum or suction applications, if the bend radius is exceeded, the hose may tend to be flat in the bend area. This will hinder or restrict flow. If the bend is severe enough, the hose may kink. To prevent minimum bend radius hose failures, double-check the recommended bend radius. Replace hose assemblies and change routing, length, or fittings to route the hose within the published minimum bend radius if they do not comply.

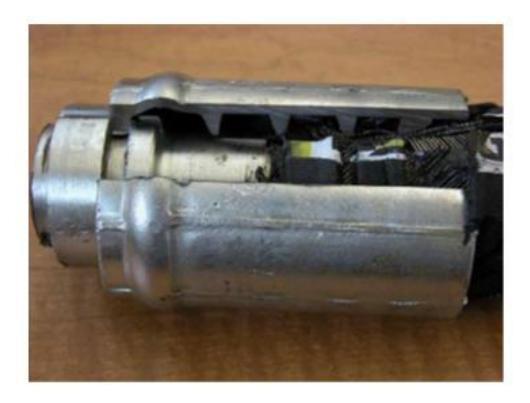
5. Insertion depth

When a hose assembly is not properly assembled, it can create very dangerous situations. Fittings need to be pushed on completely to meet the recommended insertion depth. If the hose insertion depth is not met, fittings can blow off, leaving a failed hose assembly. The last grip in the fitting shell is essential to the holding strength.

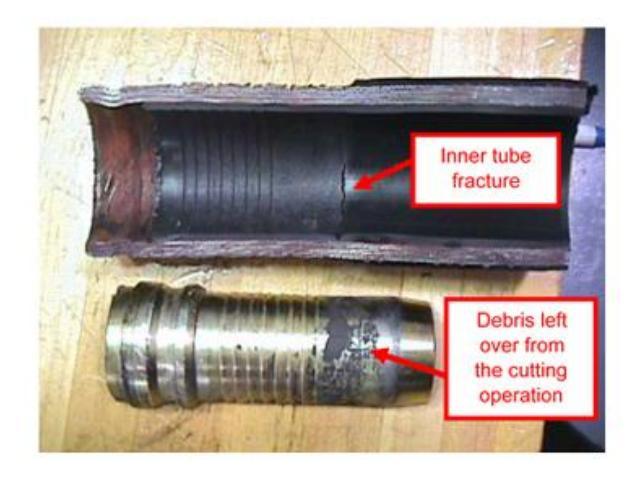
6. Improper assembly

Contamination can cause several problems for a hydraulic hose assembly. When cutting a hose, metal particles and debris can settle inside the hose if not properly flushed. This abrasive debris left in the hose will contaminate the hydraulic system. It can also cause small fractures to develop on the inner tube of the hose assembly, resulting in leakage.

To prevent hose failures from contamination, the hose must be properly cleaned before inserting the fittings. The inner tube should be "squeaky-clean" before fittings are inserted. After the fittings are crimped, be sure to cap the ends in order to keep the hose clean and avoid recontamination during transport.

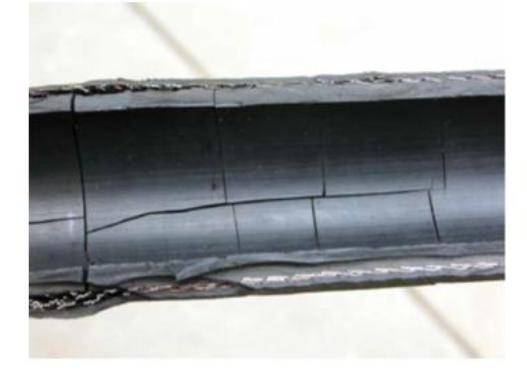
7. Heat aged

Hose failure can occur from overheating the hose assembly. Overheating will cause the hose to become very stiff. The inner tube will harden and begin to crack because the plasticizers in the elastomer will break down or harden under high temperatures. In some cases, the cover may show signs of being dried out. The hose assembly may remain in its installed shape after being removed from the application and if flexed, audible cracking can be heard.

In order to prevent overheated hydraulic hose assemblies, confirm hoses are rated for the temperatures required by your application. Also, reduce ambient temperatures or use heat guards and shields to protect the hose from nearby high-temperature areas.

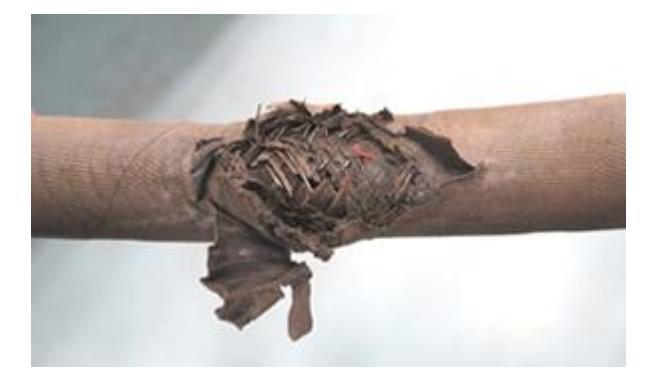
8. Abrasion

Hydraulic hoses are put through rigorous applications every day, which eventually take their toll. If not inspected on a regular basis, abrasion can cause a hose assembly to burst and leak. Excessive rubbing of the hose against an external object or even another hose can wear away the cover and eventually the reinforcement layers.

The cover is meant to protect the hose, so signs of damage to the cover or reinforcement layers should warn you that something is wrong. Protective sleeving is available to better protect against abrasion.
